## DAM BREAK DURING THE FLOOD IN SAXONY/GERMANY IN AUGUST 2002

A. BORNSCHEIN, R. POHL

Dresden University of Technology, Germany

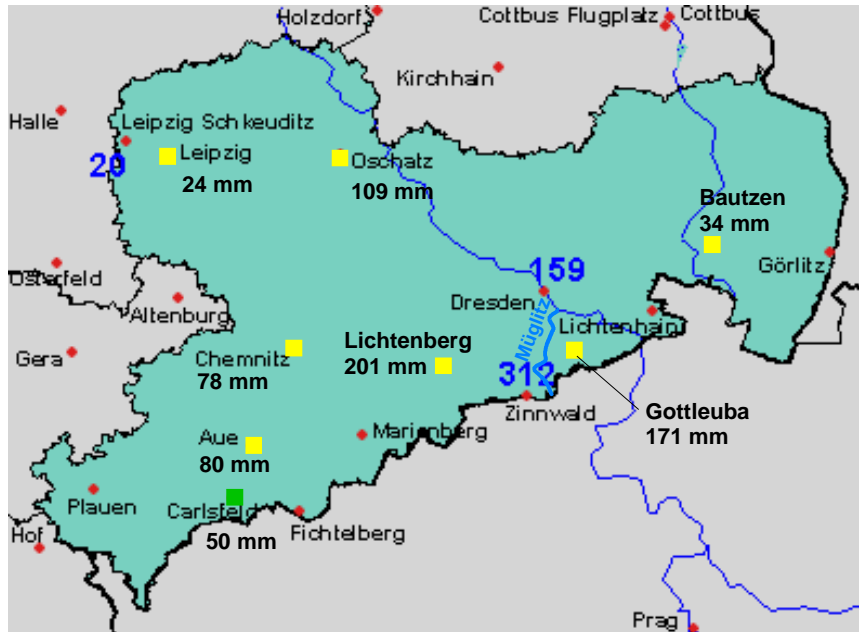
Figure 3: Rainfall map of Saxony with values of 24-hour-rainfall in mm = l/m<sup>2</sup> between 12. August 2002 7.00 a m and 13. August 2002 7.00 a m.

First analysis of rainfall for catchment areas into region yielded a peak discharge per unit area 2.3 m<sup>3</sup>/s\*km<sup>2</sup> (LfUG 2002). The whole water volume per unit area was about 200 000 m<sup>3</sup>/km<sup>2</sup>.

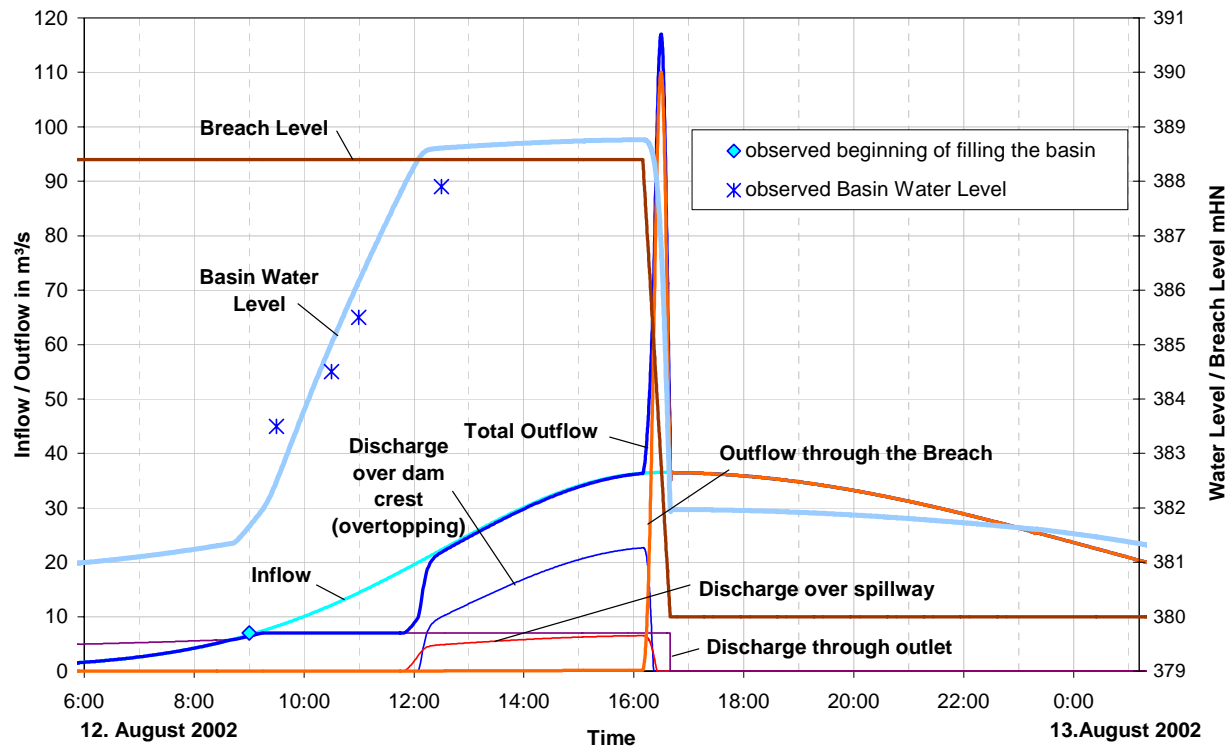
Figure 4: Calculated outflow during the flood and dam break event.

Fitting the water level graph to the observation points reported by the eye witnesses the curve in Figure 4 was yielded. From this could be derived that the dam break occurred when the inflow hydrograph reached its maximum.

An outflow peak of  $117 \text{ m}^3/\text{s}$  was calculated with an assumed linear breach extension and a breach development time of 0.5 h (as observed).

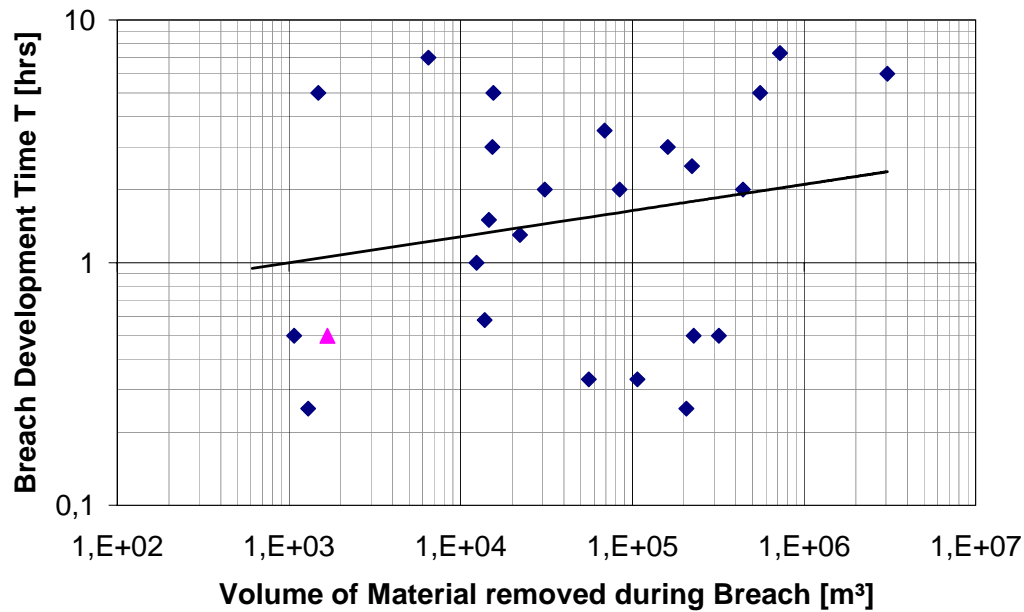
Figure 5: Removed embankment material versus breach development time - Glashütte Dam in comparison with dam break data after *MacDonald/Langridge-Monopolis 1984*.

The volume of material removed during the breach was calculated to be about  $1700 m^3$ . A comparison with values of breach characteristics of other earth dams given by *MacDonald/Langridge-Monopolis 1984* shows that the breach characteristics of the Glashütte Dam lie in the same value range.

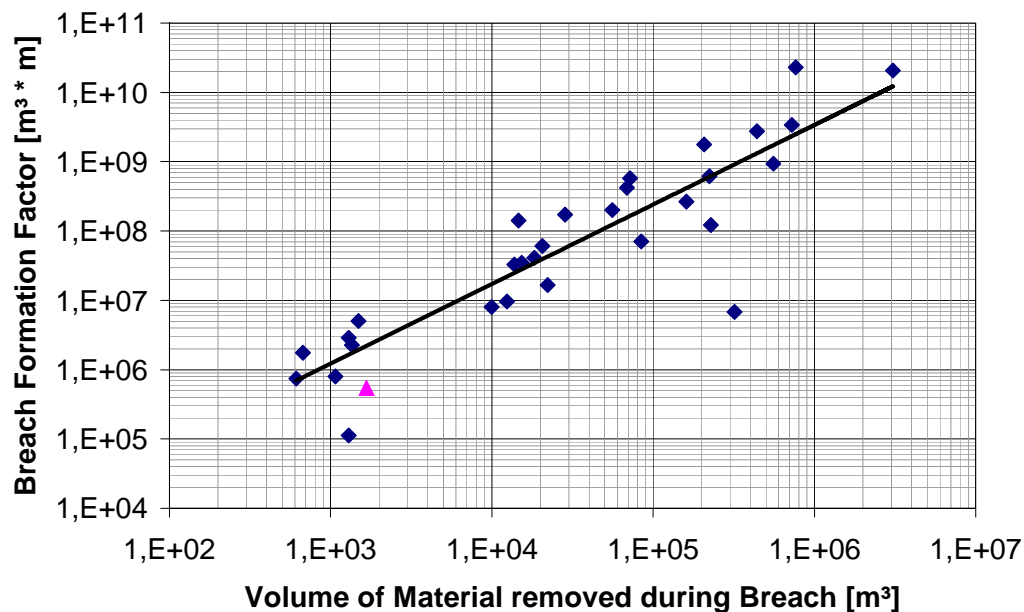
Figure 6: Removed embankment material versus BFF - Glashütte Dam in comparison with dam break data after *MacDonald/Langridge-Monopolis 1984*.

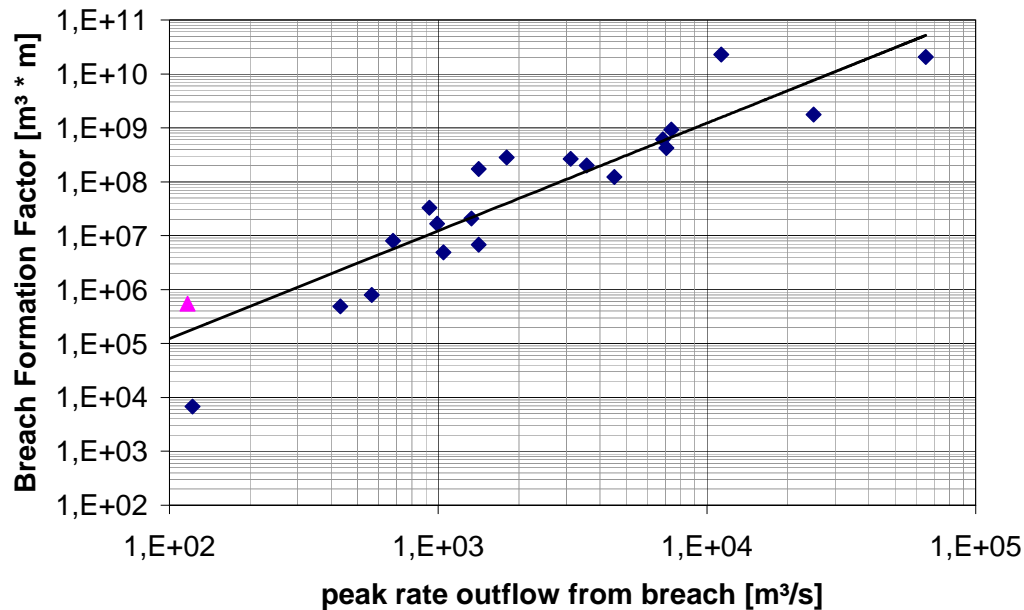
Figure 7: Peak rate outflow versus BFF - Glashütte Dam in comparison with the data by MacDonald/Langridge-Monopolis 1984.

The peak discharge is smaller than expected from the viewpoint of BFF. That is due to the relatively long breach development time of 0,5 h.

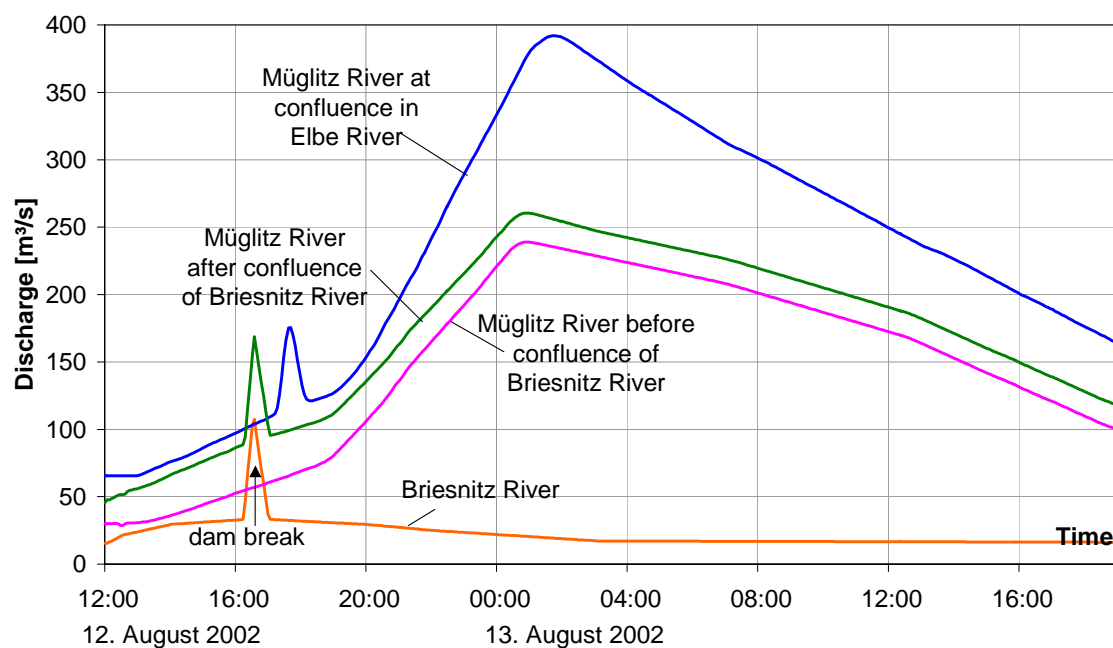
Figure 8: Calculated discharge hydrograph in the Briesnitz and the Müglitz River during the rain flood and dam break event.

As the break happened on 12. August between 4.10 and 4.40 p m its peak did not coincide with the peak caused by the rain in the Müglitz River. The graphs in Figure 8 show that the peak due to the dam break did not exceed the later passing peak of the Müglitz River. Therefore the additional damages due to the break remained limited to the direct downstream reach (Figure 9).

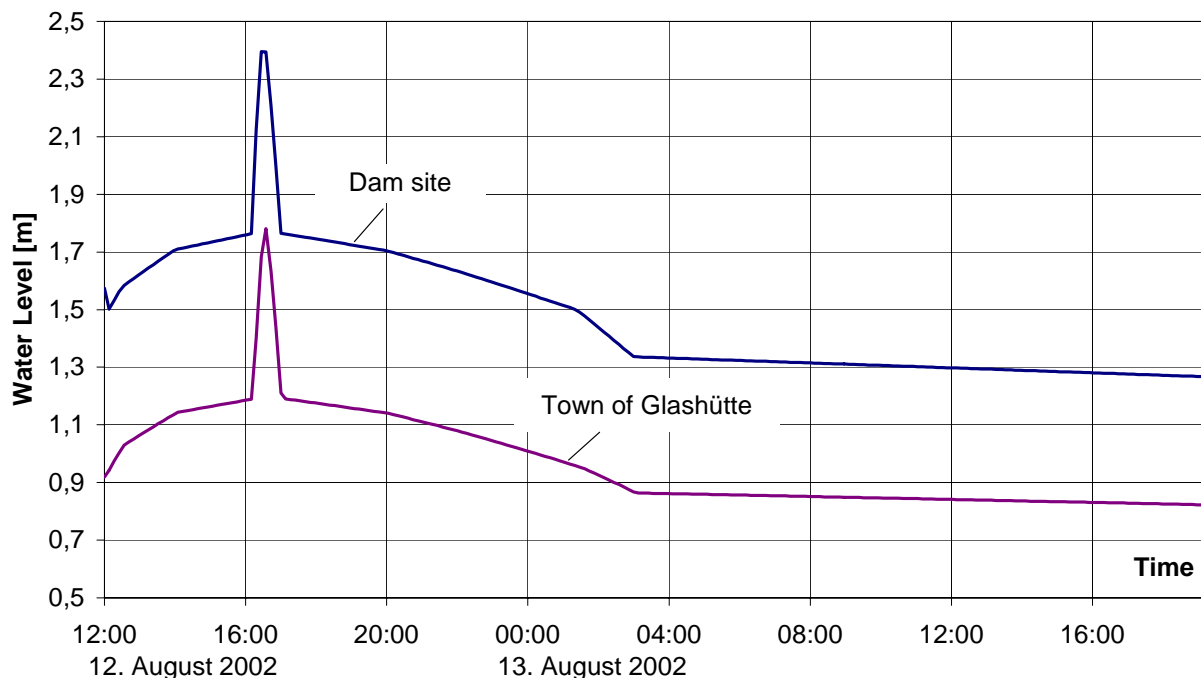
Figure 10 shows that the water level in the town of Glashütte increased of 0.5 m due to the dam break wave during a short time.

Figure 10: Calculated water level direct downstream the dam site and in the town of Glashütte.
